## **RIPARIAN BUFFER ASSESSMENT**

A rapid vegetation assessment and physical survey of the Upper Granite Creek Watershed was undertaken to assess the current functionality of the watershed channels in terms of their ability to filter pollutants from runoff. This assessment was completed by Dr. Marc Baker of Southwest Botanical Research of Chino Valley, AZ. Properly functioning riparian areas should be able to slow down surface runoff and filter out both nutrients and *E. coli* bacteria, which are pollutants of concern in this watershed.

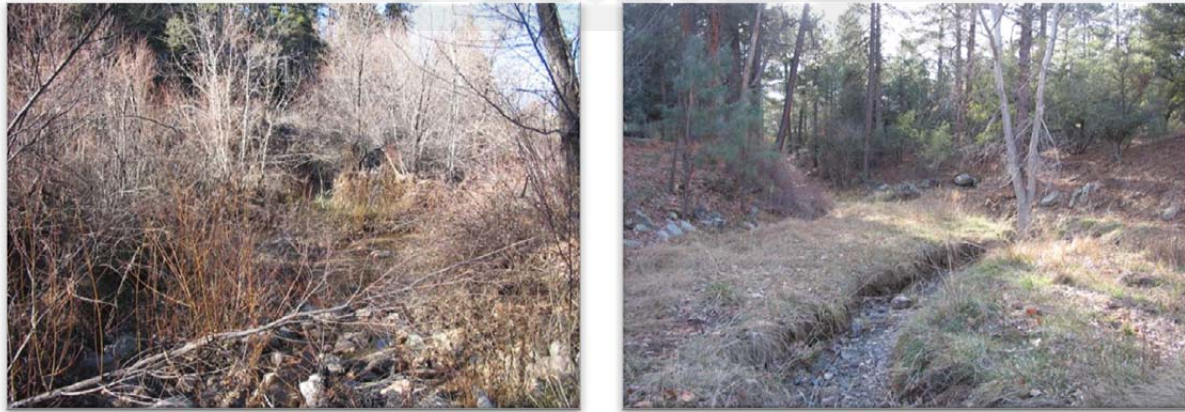
**Figure 14: High Riparian Scores**

Transects along Granite Creek (left) and Banning Creek (right) received some of the *highest riparian scores*. Higher riparian scores reflect greater vegetation cover and surface roughness along the transect as well as low bare soil.

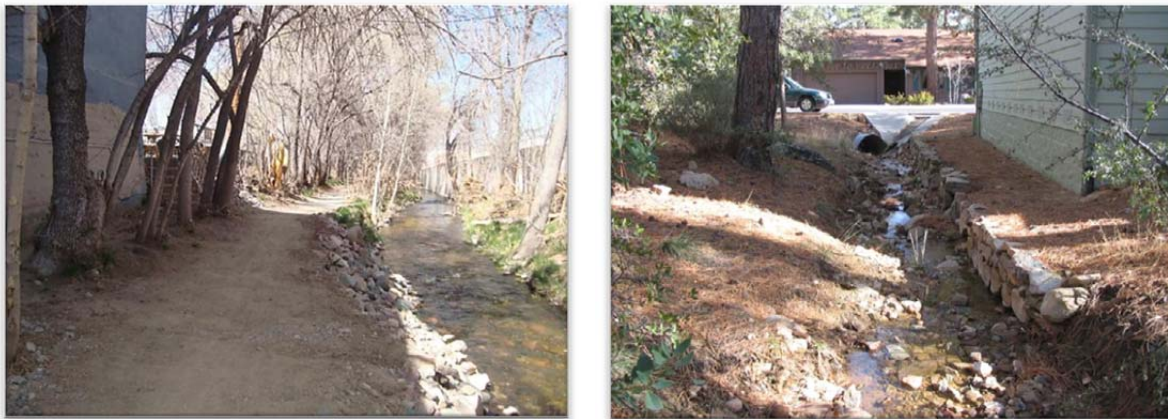
**Figure 15: Low Riparian Scores**

Transects along Granite Creek downtown (left) and Manzanita Creek (right) received some of the *lowest riparian scores*. Contrasted with the photos depicting high riparian scores above, these photos demonstrate that areas with less vegetation, more bare soil, and structures—like rock walls and paths—were likely to receive low riparian scores.

Riparian improvement projects and education would have the greatest potential for making a difference in water quality by targeting areas with transects that had both a low Riparian Score and a high Bare Soil Score.

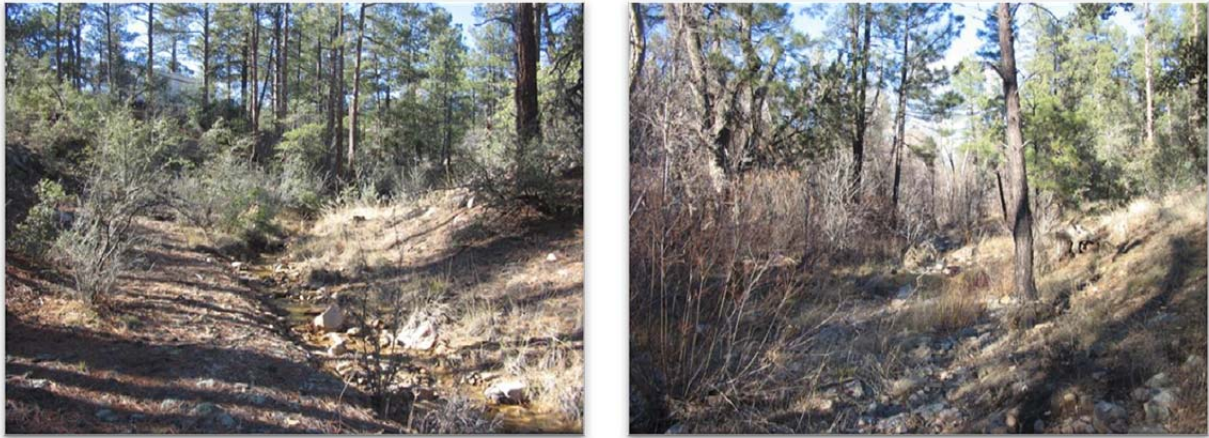
**Figure 17: Low Bare Soil Scores**

Transects along Manzanita Creek (left) and Granite Creek (right) received some of the *lowest bare soil scores*. These photos portray transects where ground cover—vegetation, litter, or duff—was prominent.

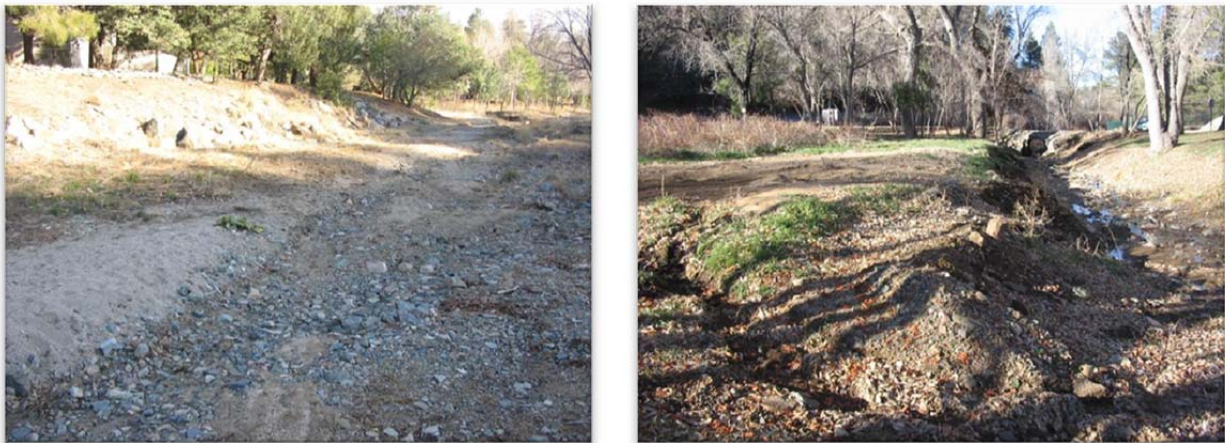
**Figure 18: High Bare Soil Scores**

Transects along Banning Creek (left) and Granite Creek (right) received some of the *highest bare soil scores*. Contrasted with the photos above, these photos show less ground cover and more exposed soil and rock.
