WATERSHED FIELD SURVEY

To gather physical data about land uses and pollutant sources, a field survey of the Upper Granite Creek Watershed was conducted in 2010 by Prescott Creeks and the Granite Creek Watershed Improvement Council. Creek Crew volunteers walked 16.5 miles of stream in this watershed to systematically document sources and causes of excess nutrients and *E. coli* bacteria in Granite Creek and its tributaries.

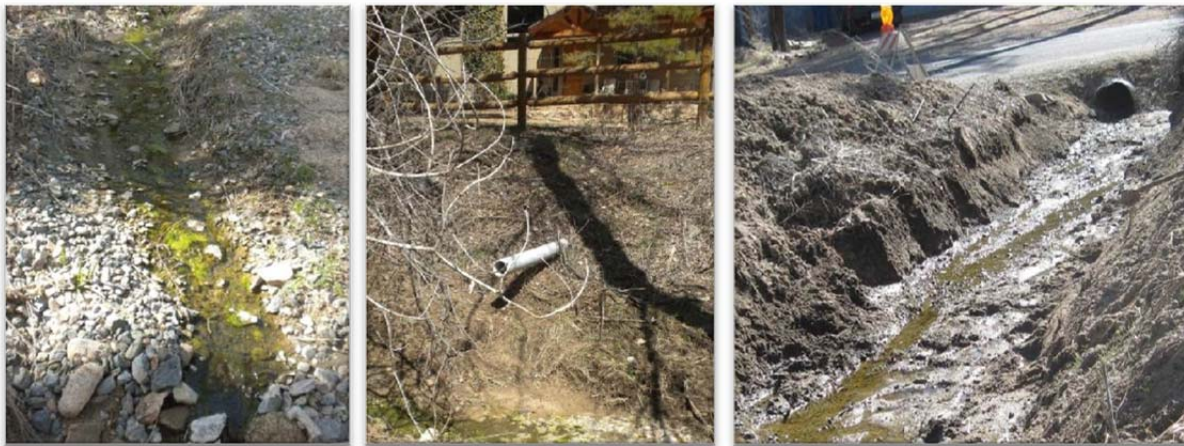
Figure 9: Stormwater Drainage Features

Stormwater drainage features observed were pipes and culverts associated with the city and county stormwater infrastructure but also unofficial pipes and ditches draining roofs and properties.

Figures 9, 10 and 11 provide examples of the types of impacts documented by volunteers through the field survey by source category.

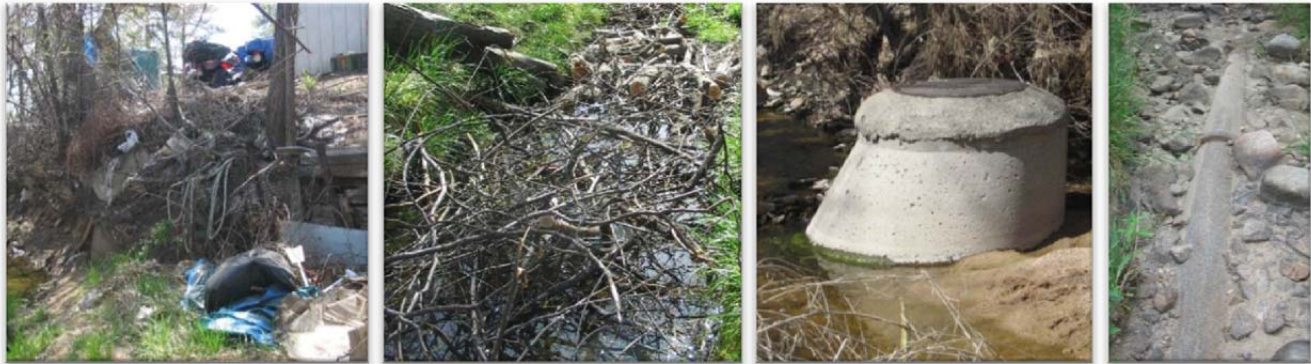
Figure 10: Pollutant Hot Spots

Pollutant hot spots were potential sources of nutrients and bacteria that were not a land use or activity within the buffer or associated with stormwater drainage. Examples of pollutant hot spots were household garbage/waste; tree and lawn trimmings; sewer lines and manholes; animal corrals or waste; and drainage from fertilized areas.

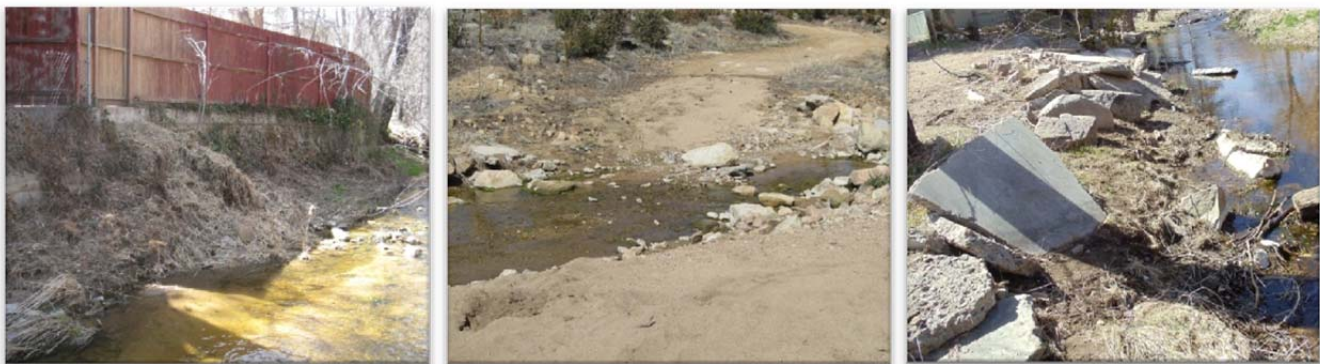
Figure 11: Buffer Impairments

Buffer impairments were recorded as any structure or land use/activity occurring within 30 feet of the creek. Common buffer impairments included roads and driveways; walls, fences, and buildings; debris and bank stabilization efforts.
